Monitoring Techniques for the X-29A Aircraft's High-Speed Rotating Power Takeoff Shaft

December 1990

David F. Voracek
Ames Research Center, Dryden Flight Research Facility, Edwards, California

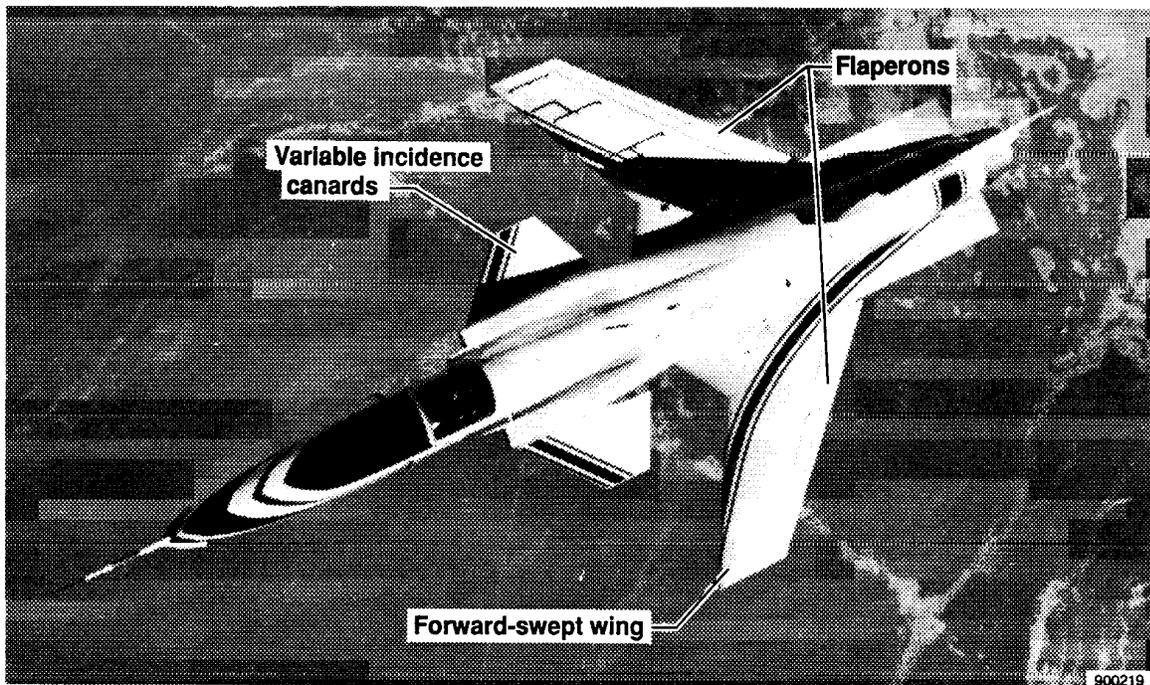
Figure 1. The X-29A forward-swept-wing aircraft.

The X-29A aircraft (fig. 1) incorporates many new technologies, the most evident of which is the forward-swept wing. The wing employs aeroelastic tailoring of advanced composite wing skins designed to avoid structural divergence and to ensure structural integrity within the flight envelope. Double-hinged trailing-edge flaperons provide both aerodynamic camber and roll control. The variable incidence canards, along with the wings and flaperons, operate together to achieve minimum trim drag. The vehicle is unstable longitudinally, with a negative static margin of 35 percent of the mean aerodynamic chord at subsonic speeds, and it is neutrally stable at approximately Mach 1.4. The flight control system includes triply redundant digital computers that provide the information to safely fly the aircraft.

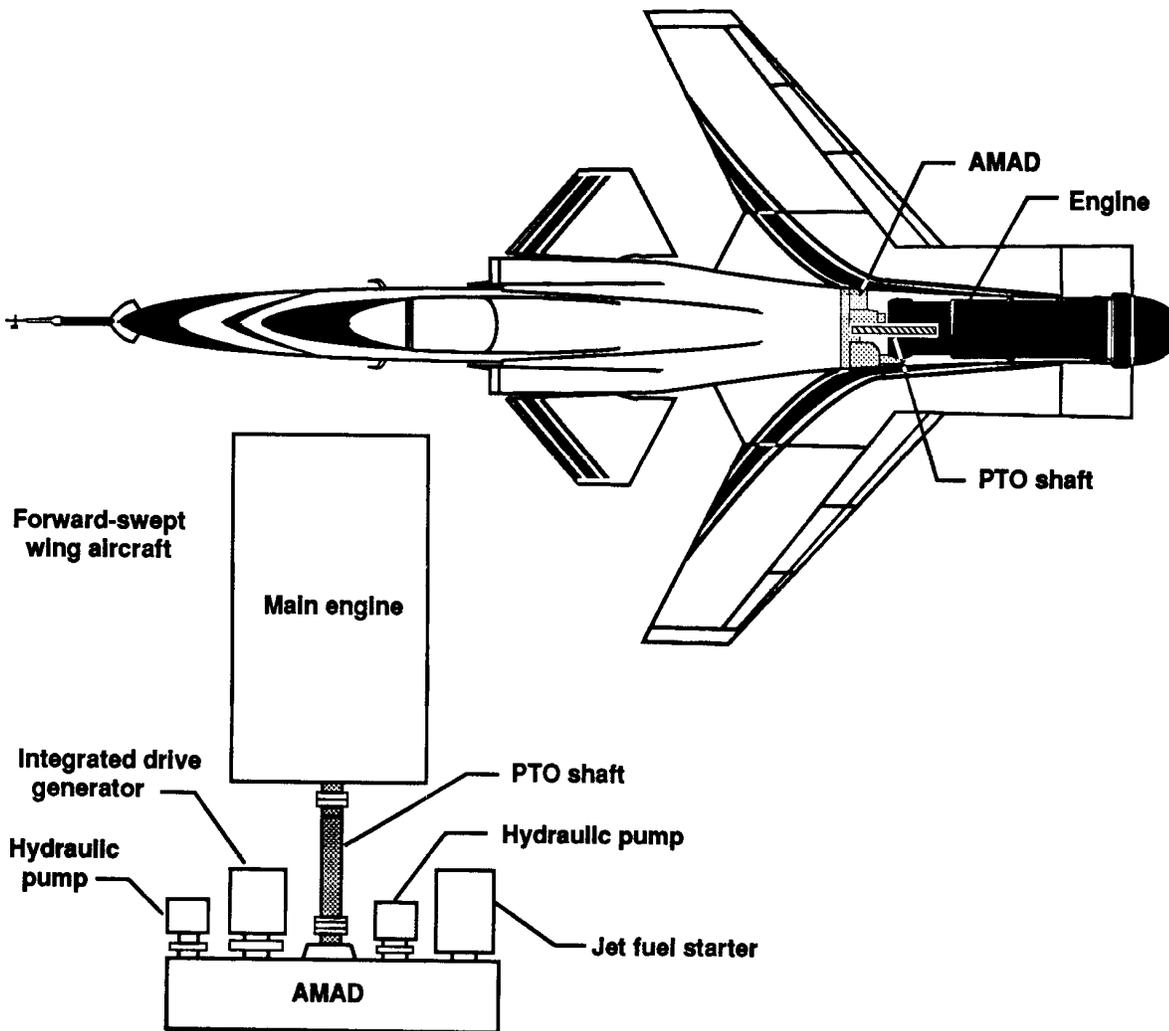
Figure 2. PTO shaft and AMAD.

The engine starting and secondary power subsystems incorporate the engine start system and the PTO shaft. The engine start system consists of a jet fuel starter system and an AMAD. Figure 2 shows an enlargement of the mounted accessories of the AMAD which consist of a starter, two hydraulic pumps, and an integrated drive generator. The PTO shaft is the direct mechanical link between the engine and the AMAD as shown in figure 2.

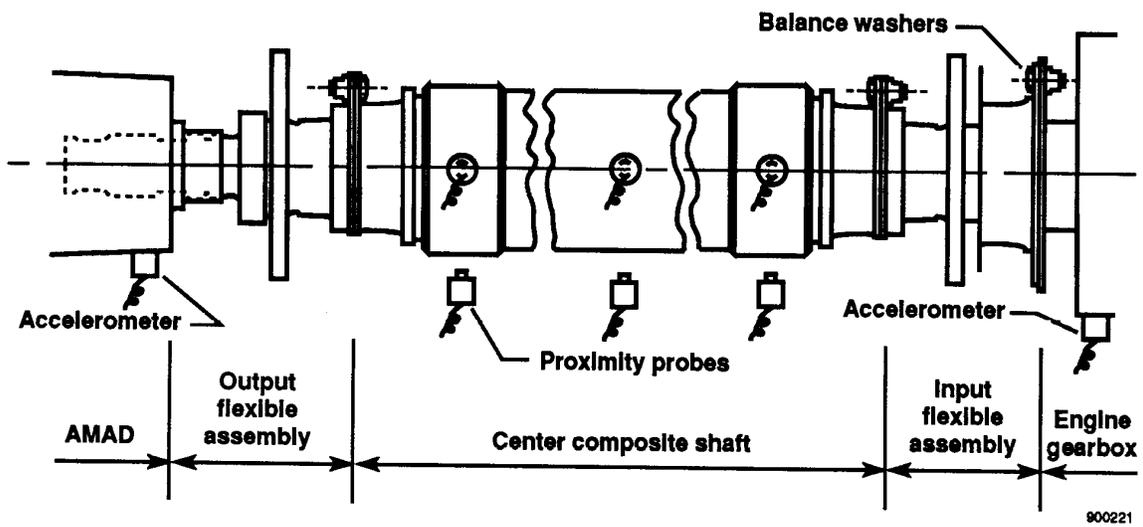
Figure 3. PTO shaft subsystem.

The PTO shaft subsystem consists of the following five subassemblies (fig. 3):

1. AMAD
2. output flexible assembly
3. center composite shaft

4. input flexible assembly
5. engine gearbox

The first section, the AMAD, powers the two hydraulic pumps and the integrated drive generator, which supplies aircraft hydraulic and electrical power. The second and fourth sections, the output and input flexible assemblies, are designed to absorb any axial loads that the shaft may experience. They also provide a centering ball design which prevents the shaft from “whipping” in case of failure.⁽²⁾ The third section, the center composite shaft, transmits the rotary power between the AMAD and the main engine in two modes. In the first mode, the engine starting-motoring mode, power is transmitted through the AMAD to the main engine gearbox which is geared to the main engine high-pressure compressor spool. In the second mode, the accessory drive mode, power is transmitted from the main engine gearbox to the AMAD to drive the AMAD-mounted accessories.

The high rotational speeds between 0 and 16,810 rpm of the X-29A PTO shaft require a high degree of dynamic balance between its subassemblies to prevent destructive vibrations and harmonics. The gearbox, AMAD, and composite shaft components of the assembly are balanced dynamically as a unit during manufacturing. The following table shows the balanced component matrix for two AMADs, three PTO shafts, and three engine gearboxes. Washers were used to balance the PTO subsystem and were mounted under the bolts connecting the engine gearbox to the input flexible assembly as shown in figure 3.

The ground and flight limits established by the engine and airframe manufacturers were based on the allowable limit radial loads for the engine gearbox duplex bearings. Initial engine ground runs were accomplished with the PTO shaft instrumented with proximity probes (fig. 3) to establish a relationship between the shaft deflection and the engine bearing loads. This relationship was established because the accelerometer used for flight and ground monitoring was located on the engine gearbox assembly. The AMAD limits were developed in a similar procedure also based on the gearbox duplex bearing loads. The recommended acceleration limits, which were established by analysis and ground testing for the gearbox, consist of 2.7 *g* at 80 percent (227 Hz) of the engine speed during the engine ground runs and a 6.0-*g* limit during flight. The limits for the AMAD are shown in figure 5.

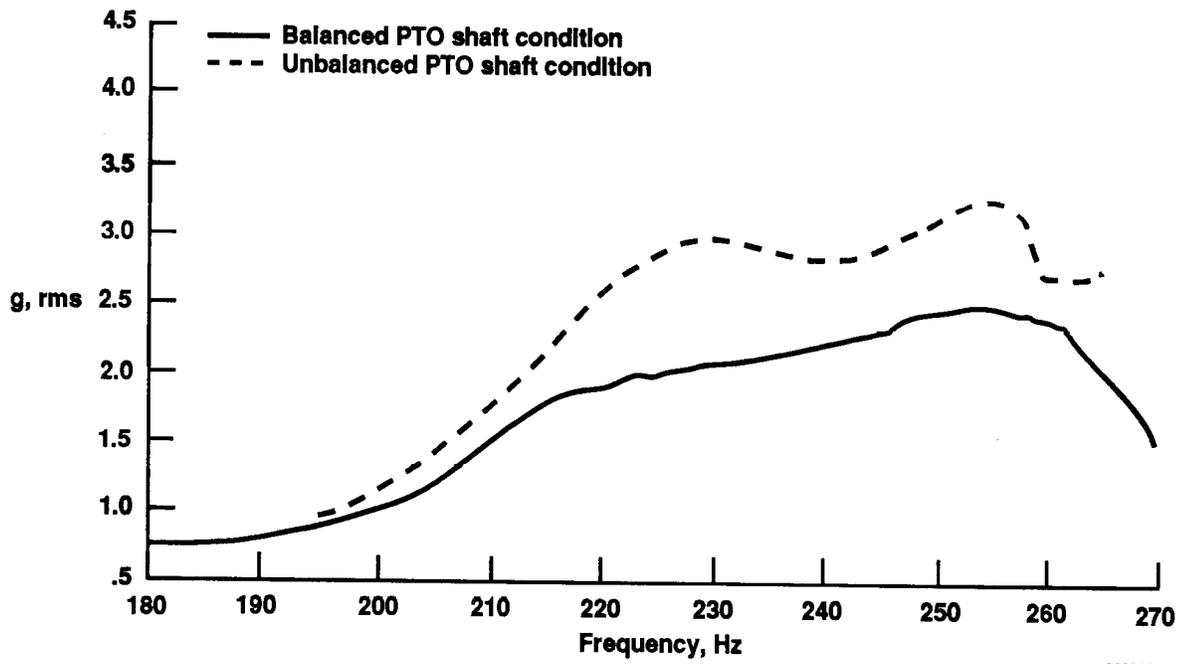
Figure 4. Effect of an unbalance on PTO shaft vibration levels.

During the initial evaluation of the PTO shaft, engine runs were performed with the PTO shaft in both a balanced condition and in an out-of-balance condition. These tests determined the effect of a known shaft unbalance on the gearbox vibration levels. In figure 4, the unbalance increased the vibration levels throughout the operating rpm range.

The real-time flight test monitoring of the PTO shaft vibration characteristics was the main method used to assess the vibration levels of the shaft. The monitoring used the same equipment and methods of the engine ground runs. Vibration levels were measured using the accelerometers located on the AMAD and engine gearbox during flight throughout the operating speed range of the PTO shaft. Using a strip chart and a spectrum analyzer, the vibration levels were determined, tabulated, and compared with nominal balanced data (fig. 4) to determine PTO shaft performance.

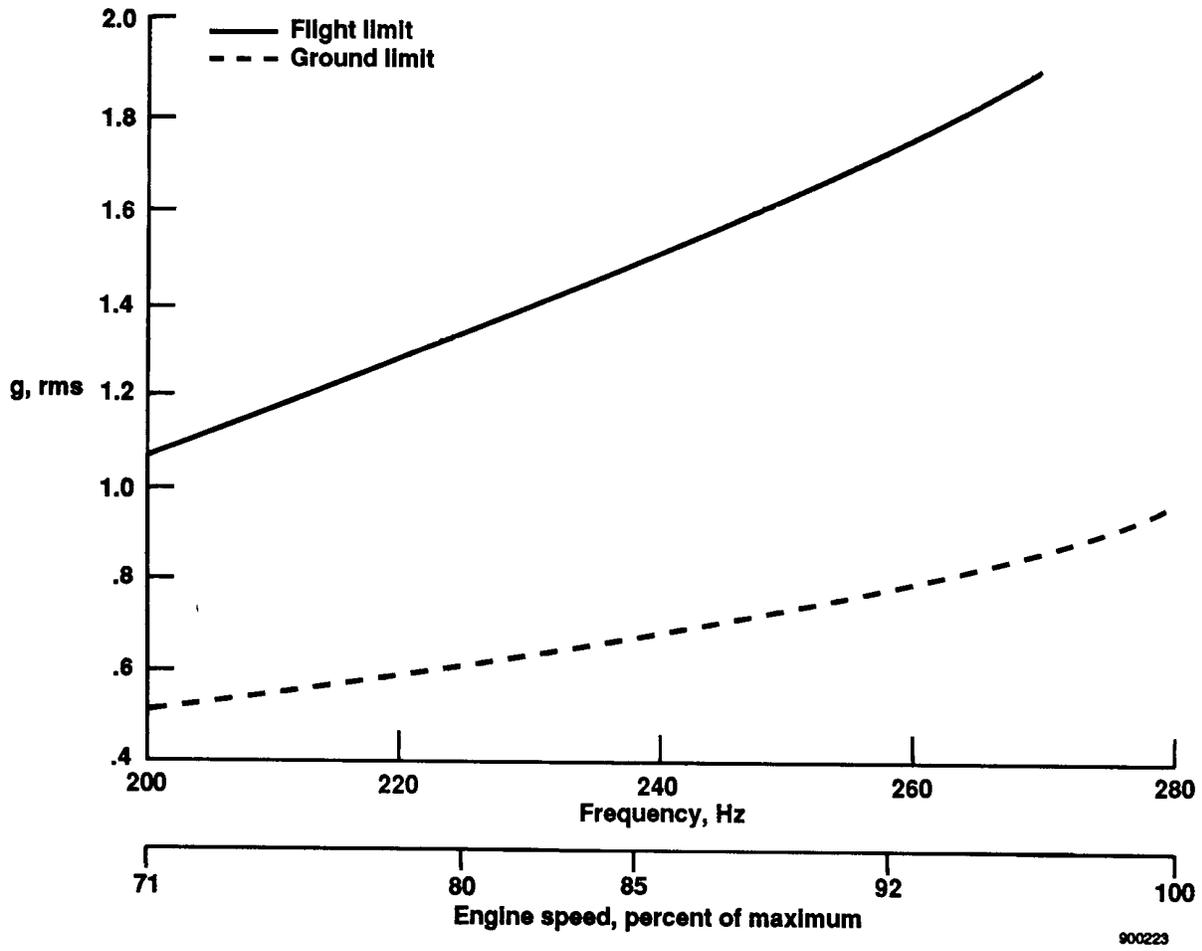
Figure 5. The X-29A AMAD vibration limits.

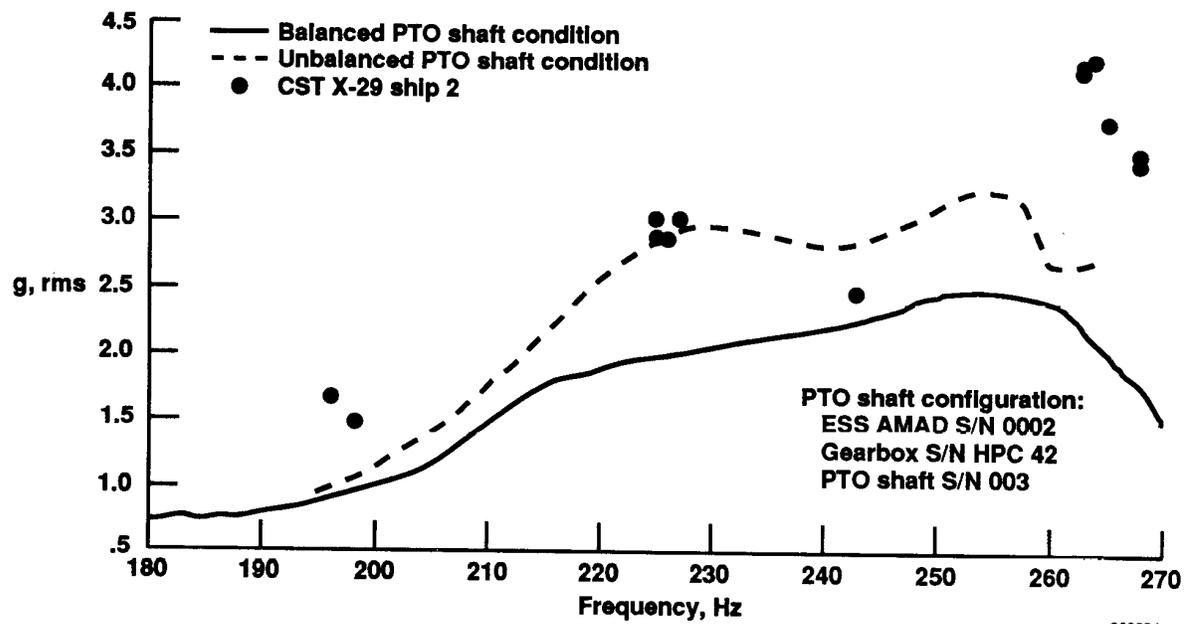
Figure 6. Combined systems test gearbox acceleration data.

During the course of the X-29A program, a complete check of all systems including instrumentation, aircraft, and control room operation was conducted. This complete check is called a combined systems test (CST). The gearbox and AMAD data compiled for the second X-29A aircraft during its initial CST are shown in figures 6 and 7. The higher acceleration levels of the gearbox and AMAD indicate an unbalanced shaft installation.

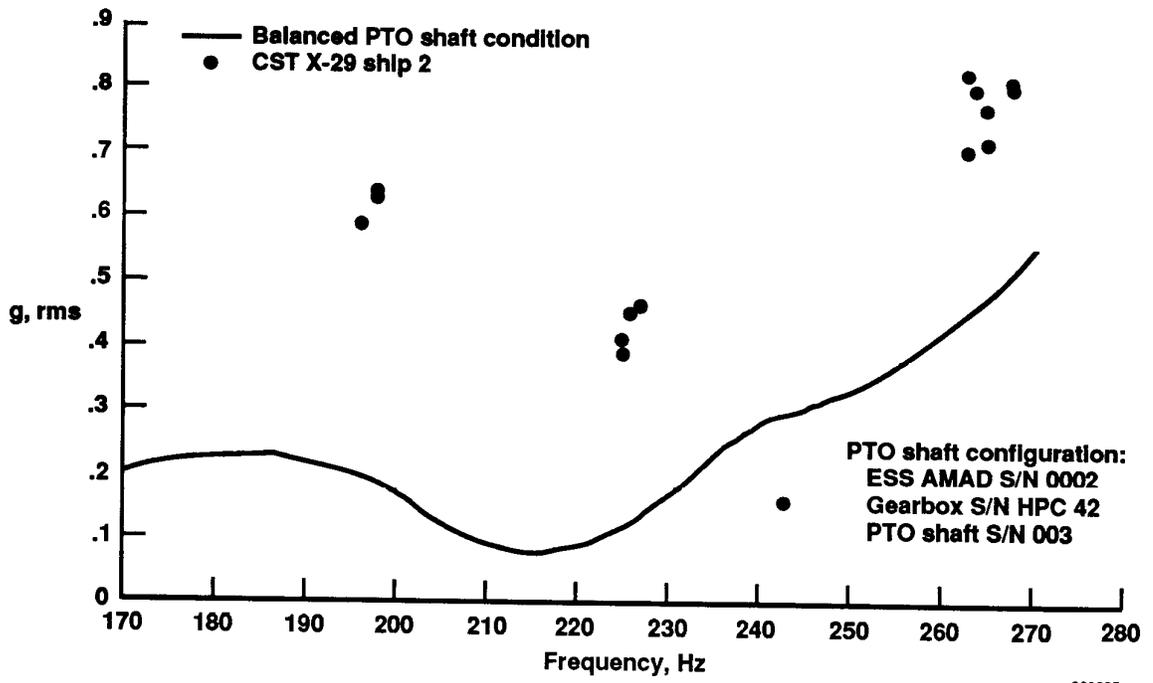
Figure 7. Combined systems test AMAD acceleration data.

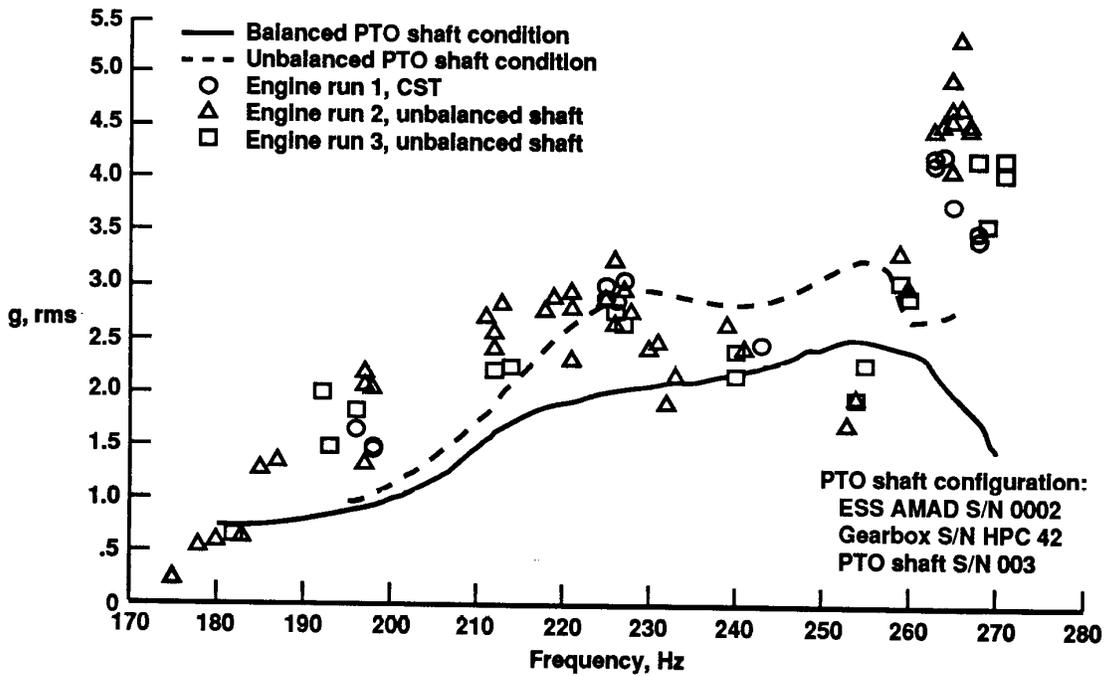
Figure 8. Gearbox engine run data during unbalanced shaft installation.

Several ground runs were performed to troubleshoot the unbalanced PTO shaft. Figures 8 and 9 show the data for three of the engine runs along with the configuration of AMAD, gearbox, and the PTO shaft that was installed during the runs. The first run, the CST, was where the higher vibration levels were first seen. The second engine run was done after a complete check of all the PTO shaft accelerometers and the parameter setup in the control room for any anomalies. After the check, the data were found to be repeated with no significant decrease in the acceleration levels. A more detailed study of the installation procedure found that the PTO shaft was rotated 90° from the correct markings on the shaft. After the shaft was rotated correctly, another engine run was performed. The data showed no major reduction in vibration levels.

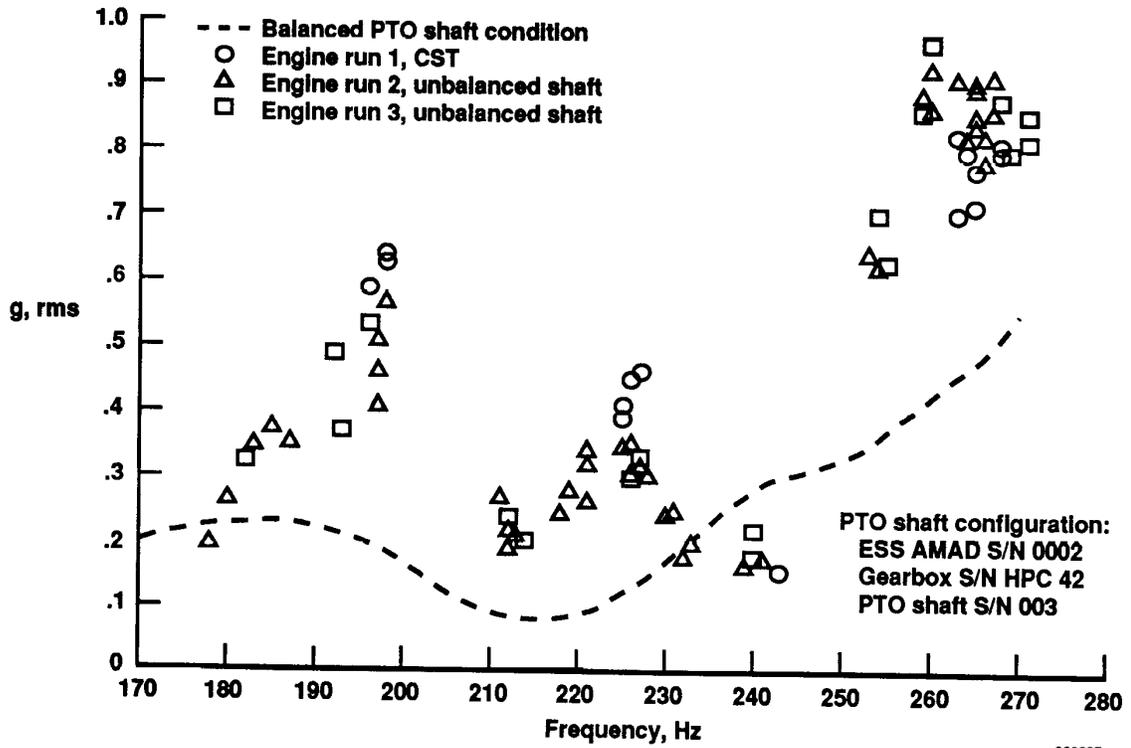
Figure 9. AMAD engine run data during unbalanced shaft installation.

The data in figures 9, 12, and 13 show that as the frequency of the PTO shaft approached 200 Hz, the amplitude of the vibration increases. The AMAD strip chart trace in figure 14 shows that the signal from the AMAD accelerometer resembles a sine wave with a calculated frequency of approximately 0.40 Hz. This frequency was termed the beat frequency or frequency difference of two closely spaced modes of vibration. The second trace in figure 14 shows the engine speed in percent of the maximum speed. Interestingly, as the engine speed approached approximately 71 percent or 200 Hz, the amplitude of the beat increases confirmed the plotted acceleration data.

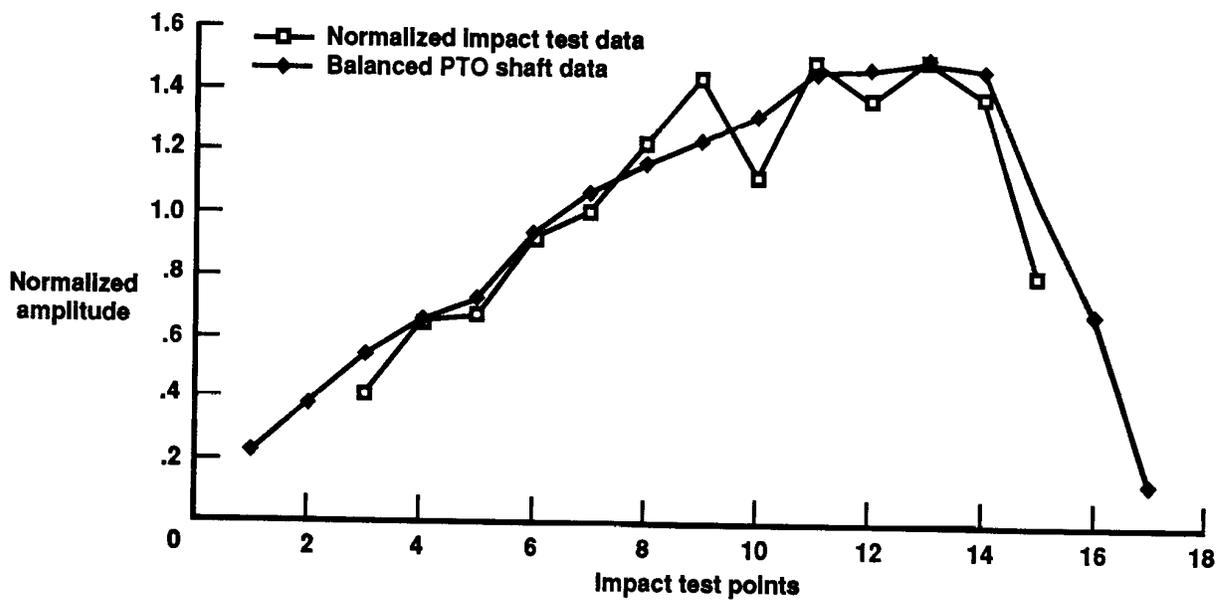
Figure 10. PTO shaft mode shapes comparison.

A shaft GVT was then performed to verify the structural integrity of the PTO shaft. The GVT test of the installed shaft measured the frequency of the PTO shaft mode and compared the data with previously measured data of a balanced PTO shaft. From the response signatures, the vertical and lateral mode frequencies were found to be 362 Hz and 353 Hz, respectively. Both responses are above the design criteria of 300 Hz. The normalized mode shape for the vertical mode is shown in figure 10 along with the mode shape from a known balanced PTO shaft. The data obtained from the GVT closely follow the mode shape of the balanced shaft. The GVT data indicate that the PTO shaft was not damaged and that a problem exists in the installation, or that the shaft assembly itself was unbalanced.

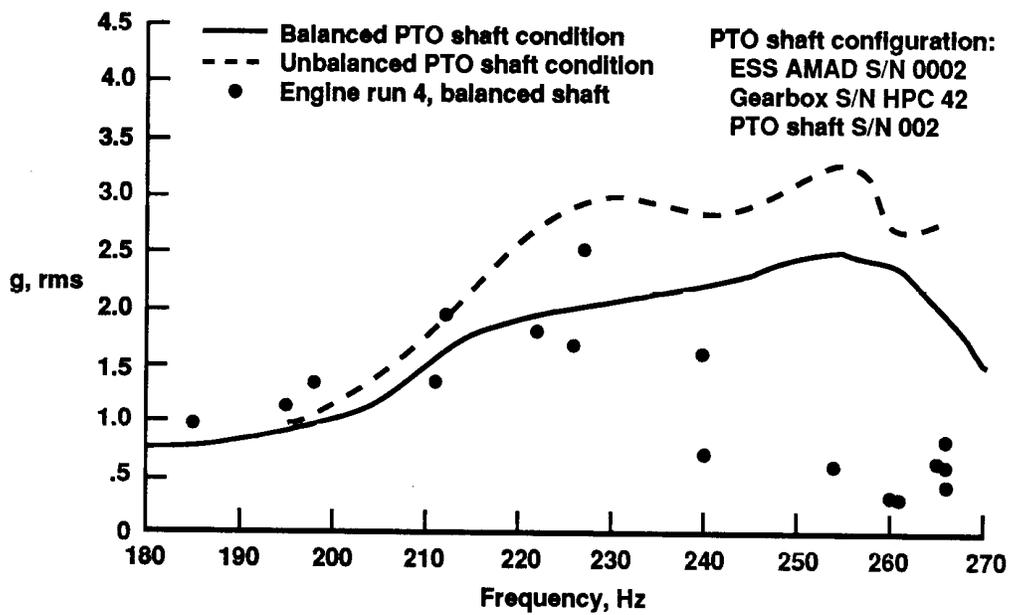
Figure 11. Gearbox engine run data after PTO shaft change.

In lieu of rebalancing the current configuration (PTO shaft S/N 003, gearbox S/N HPC 42, and AMAD S/N 0002), it was decided to change to PTO shaft S/N 002, which had also been balanced with the current gearbox, and AMAD, as shown previously in the table. This PTO shaft was installed on the X-29A aircraft, and another engine run was performed. The data in figures 11 and 12 show a reduction in the vibration levels of the gearbox and AMAD, respectively. The reduction in vibration levels indicates that the configuration was installed correctly and was balanced.

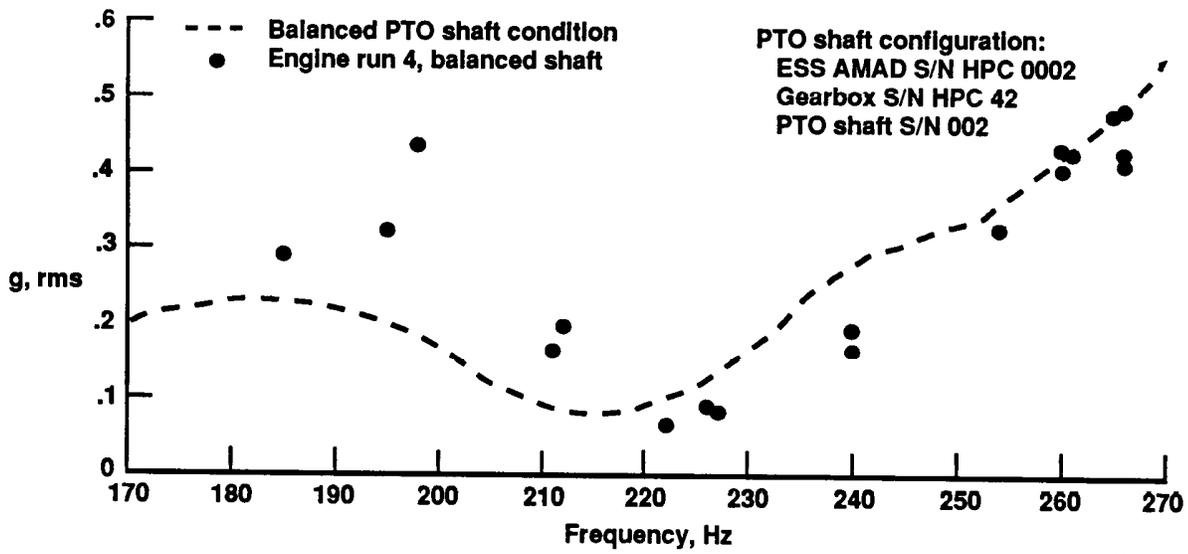
Figure 12. AMAD engine run data after PTO shaft change.

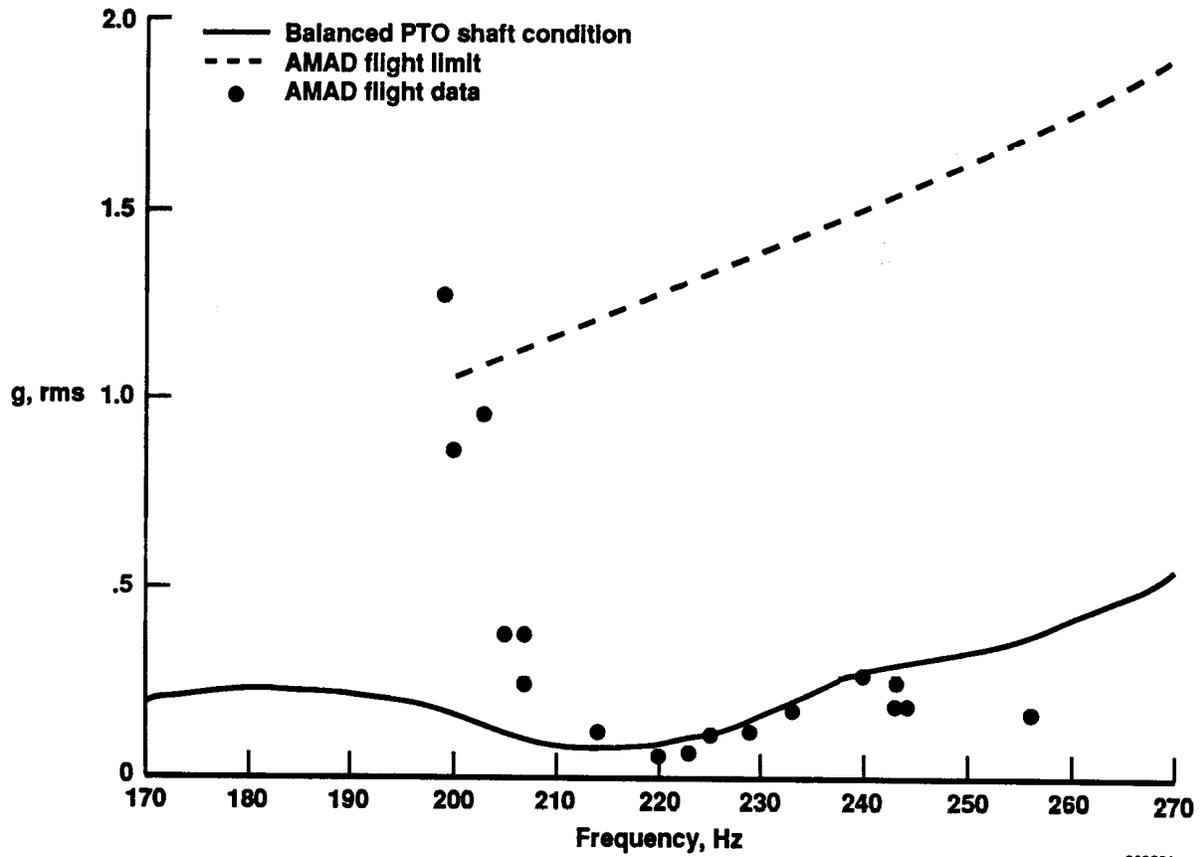
Figure 13. The X-29A AMAD vibration data, ship 2, flight 1.

The AMAD vibration limit was exceeded during the initial flight of the second X-29A aircraft. This occurred at approximately 199 Hz, which corresponds to an engine speed of just under 12,000 rpm or a frequency of 200 Hz (fig. 13). At frequencies above 200 Hz, the AMAD vibration levels were within the established limits. The gearbox data showed no unusual trends and did not exceed any limits. The data indicated that the PTO shaft was balanced and that another unbalance existed in the AMAD.

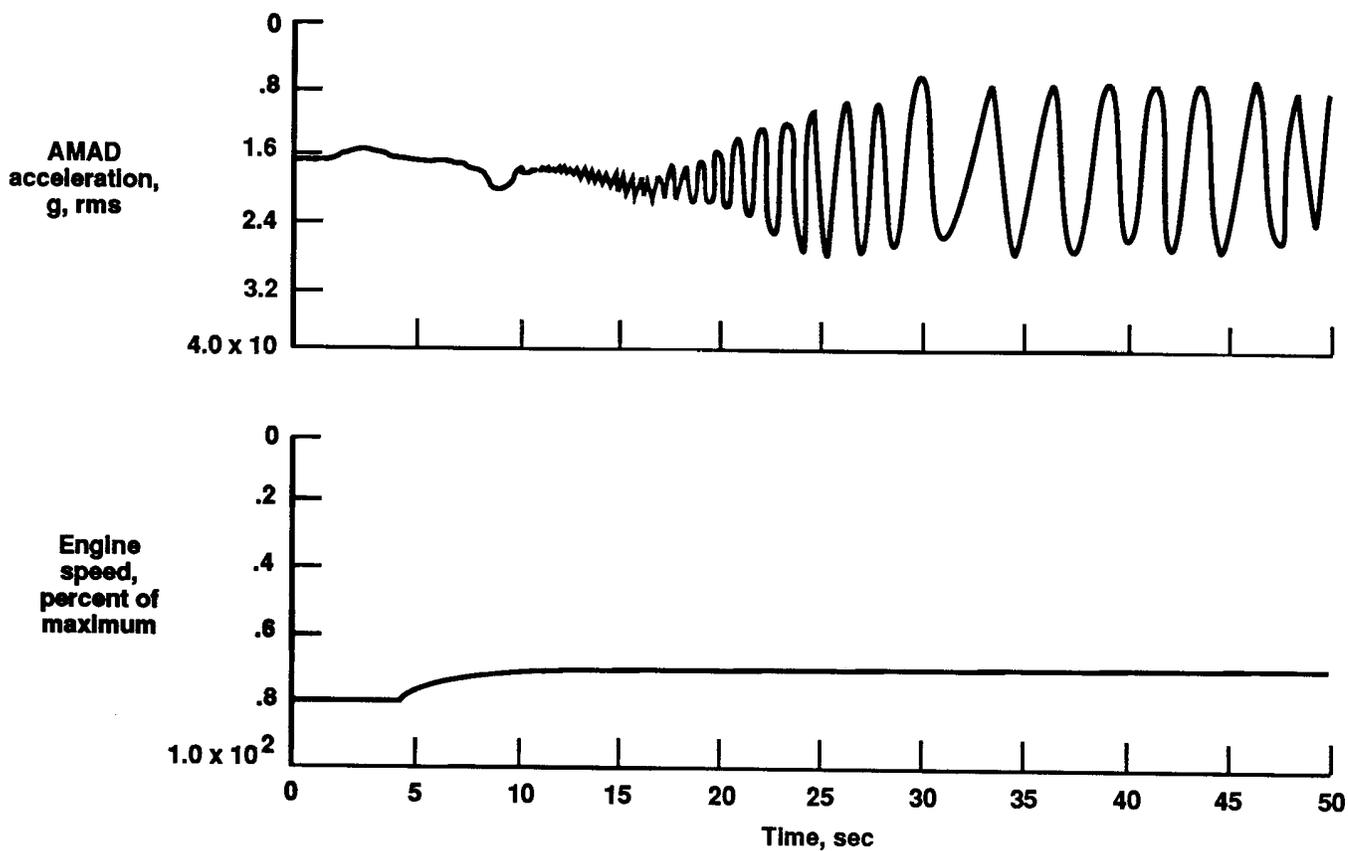
Figure 14. AMAD vibration and engine speed time history.

As the engine speed trace in figure 14 confirms, the higher AMAD vibration levels occur when the engine compressor speed is in the range of 71 percent of the maximum operating speed of 16,810 rpm, the flight idle speed of the X-29A aircraft. Figure 16 shows that a high vibration level could only occur below 10,000 ft and Mach 0.6. These conditions would most likely occur during the takeoff and landing of the X-29A aircraft.

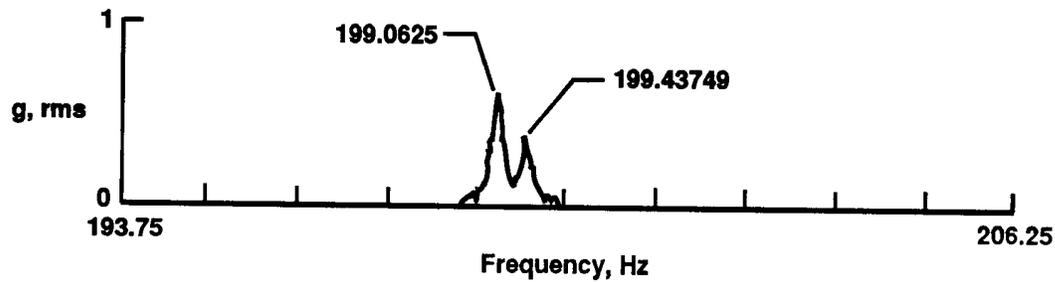
Figure 15 AMAD accelerometer power spectrum.

The power spectrum of the AMAD accelerometer in figure 15 zoomed in at approximately 200 Hz, confirming the presence of two closely spaced modes. The frequency difference calculated from the power spectrums indicated about the same frequency difference as the strip chart trace.

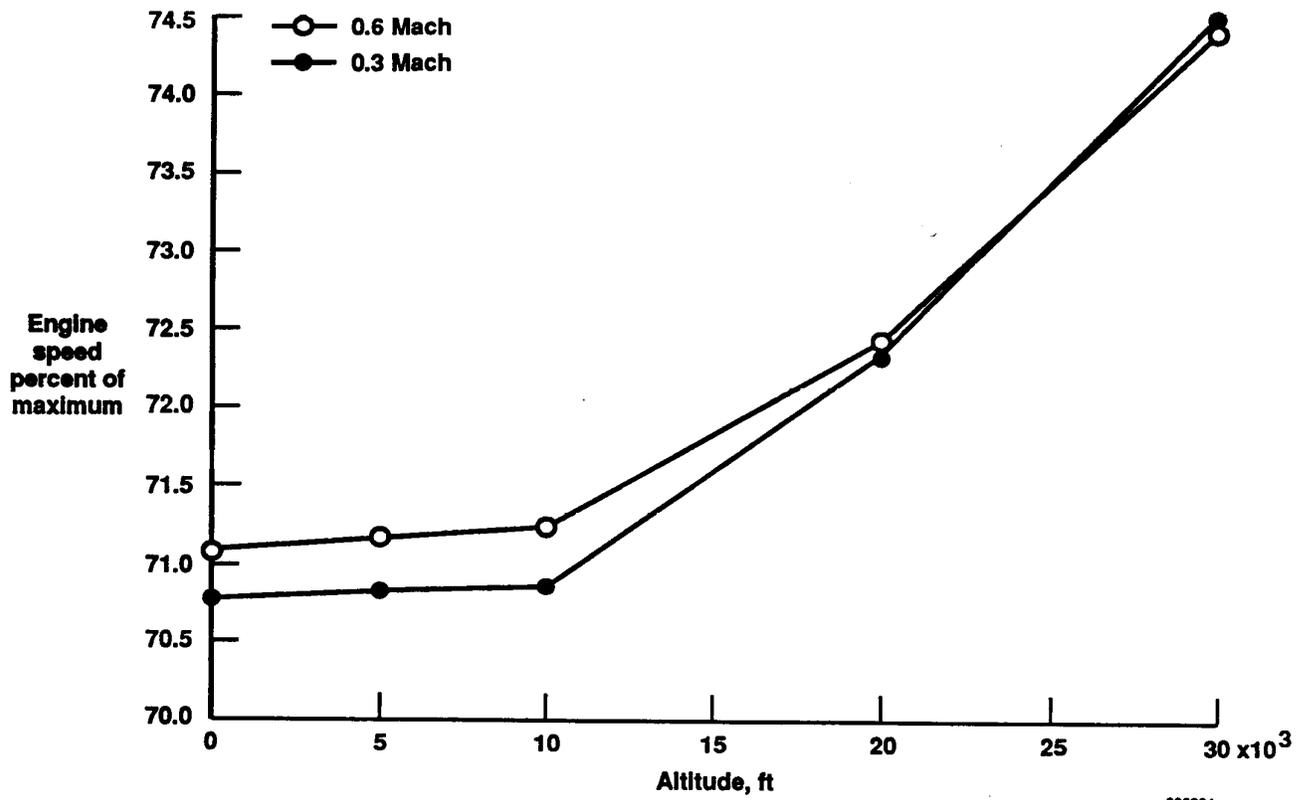
Figure 16. Engine speed variation.
